**CITY OF MOUNTAIN VIEW
MEMORANDUM**

SUBJECT: DEL MEDIO PARK, PROJECT 10-41—CONCEPTUAL DESIGN

Arborist Report

**Del Medio Park
380/390 Del Medio Avenue
APN 148-12-033 & 034
Mountain View, CA**

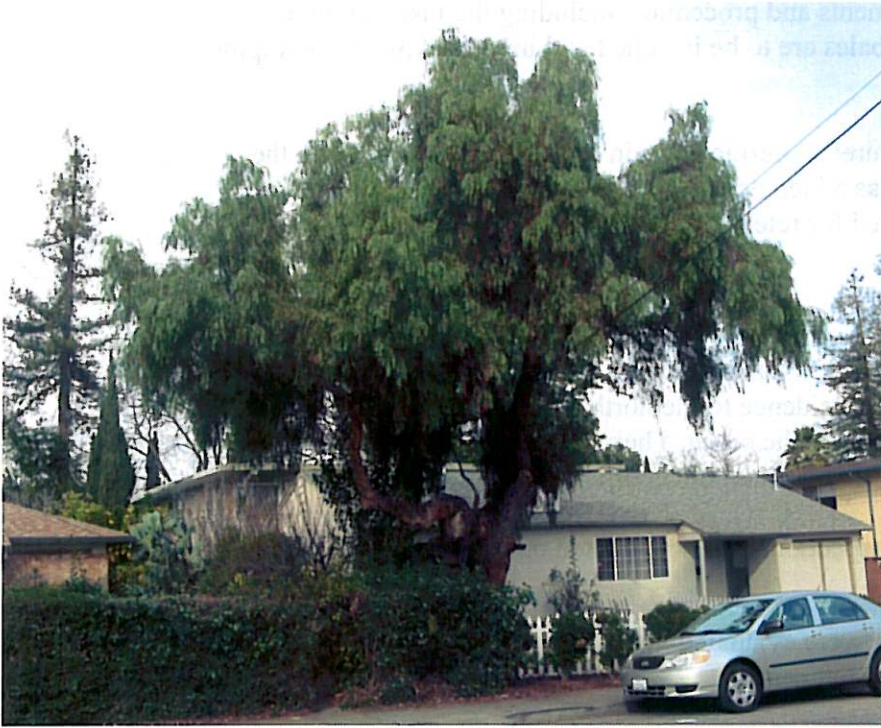
The key tree on the site is a California pepper, Tree #1 pictured on the following page. It stands at the front of the project midway between the property extents. It is in fair condition although significant, large diameter branches have been removed which has detracted from the aesthetics of the tree.

It is assumed that this tree is an asset to the community; preservation and protection during construction will be of importance.

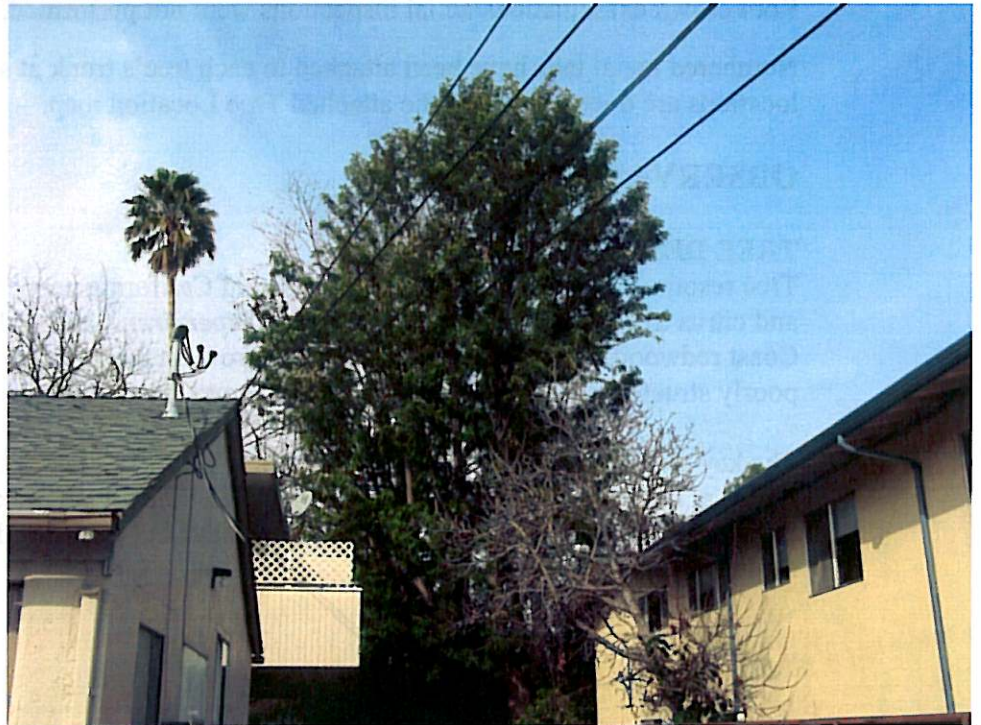
Tree #2 stands on the adjacent property to the north and east. Canopy extents reach over the proposed park area and are at extreme risk of stem or branch failure.

Tree #2 is a poorly structured silk oak. This tree has poor trunk/stem attachments that are at risk of failing. This tree should be removed or reduced in height prior to construction

Tree #2 grows from the neighboring property. It is poorly structured and prone to major stem/branch failure

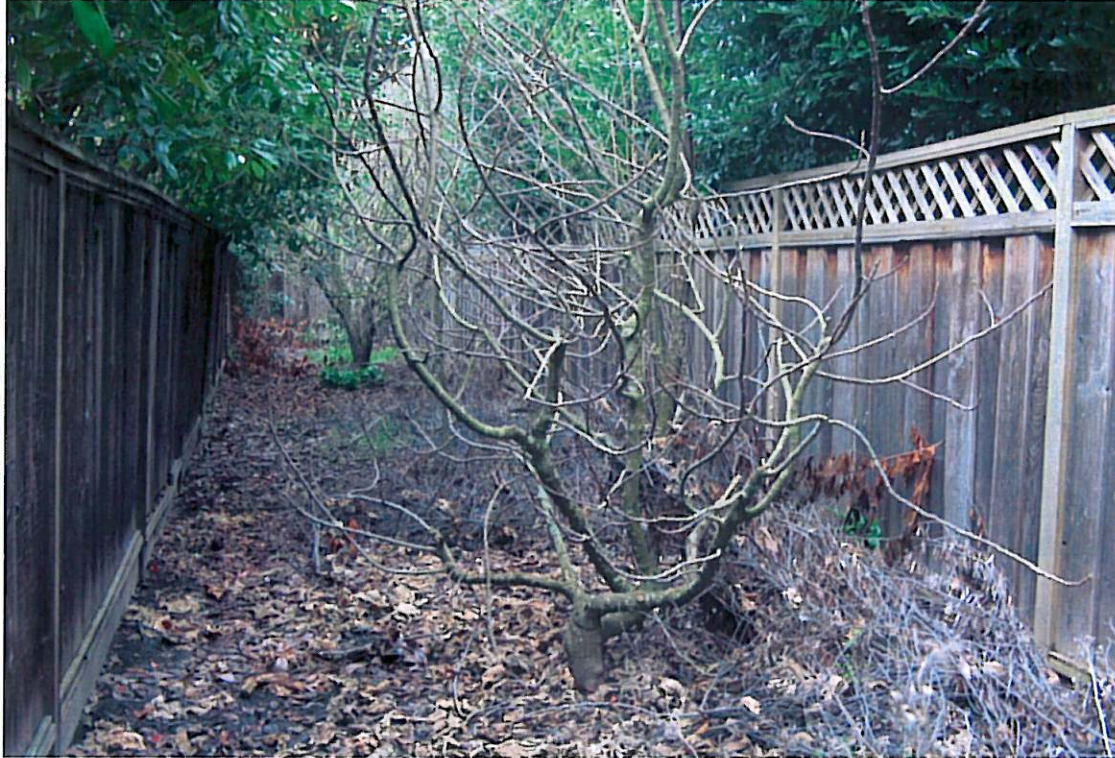
There are approximately 30 fruit trees the majority of which may be unsuitable for preservation. Canopies are low growing and unmaintained; branches may interfere with safe use of the park.

Trees pictured above grow in the panhandle portion of the lot. This section of the property is to be separated and will not be incorporated into the park.

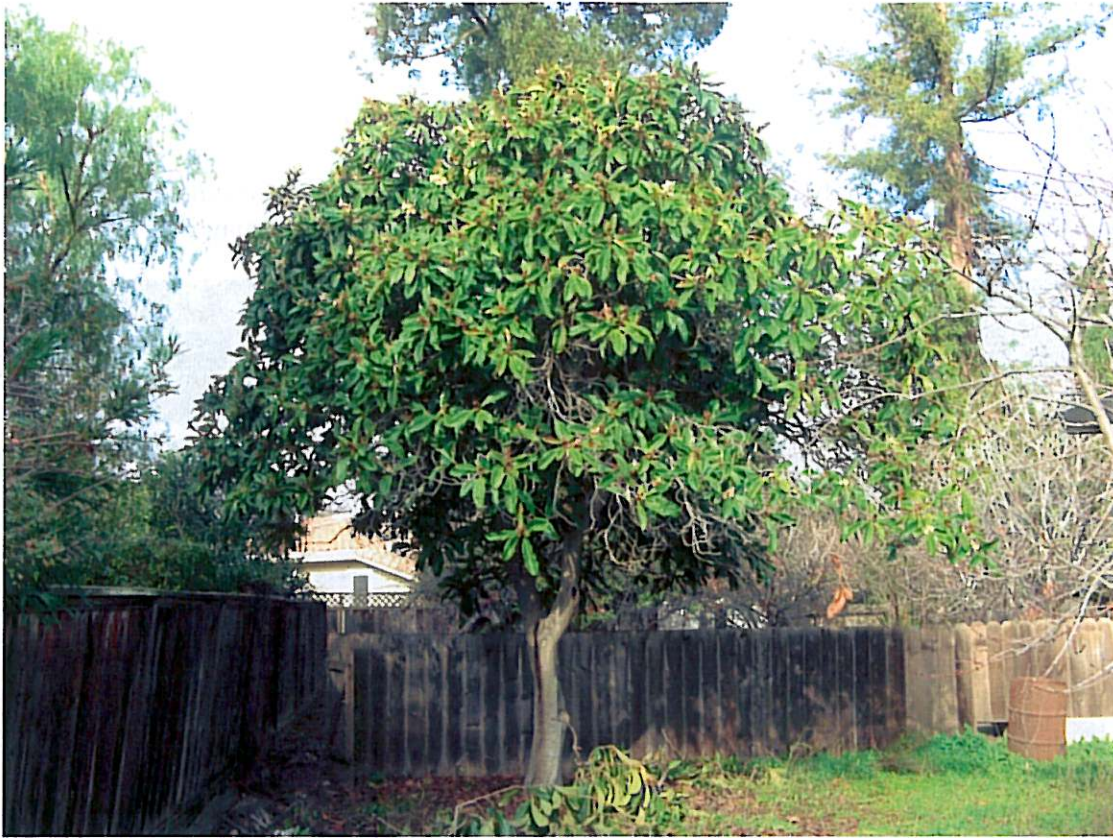
Trees #14 and 16, loquat trees, #14 is poorly structured and subject to failure. Tree #16, pictured above is well structured and a good preservation candidate.

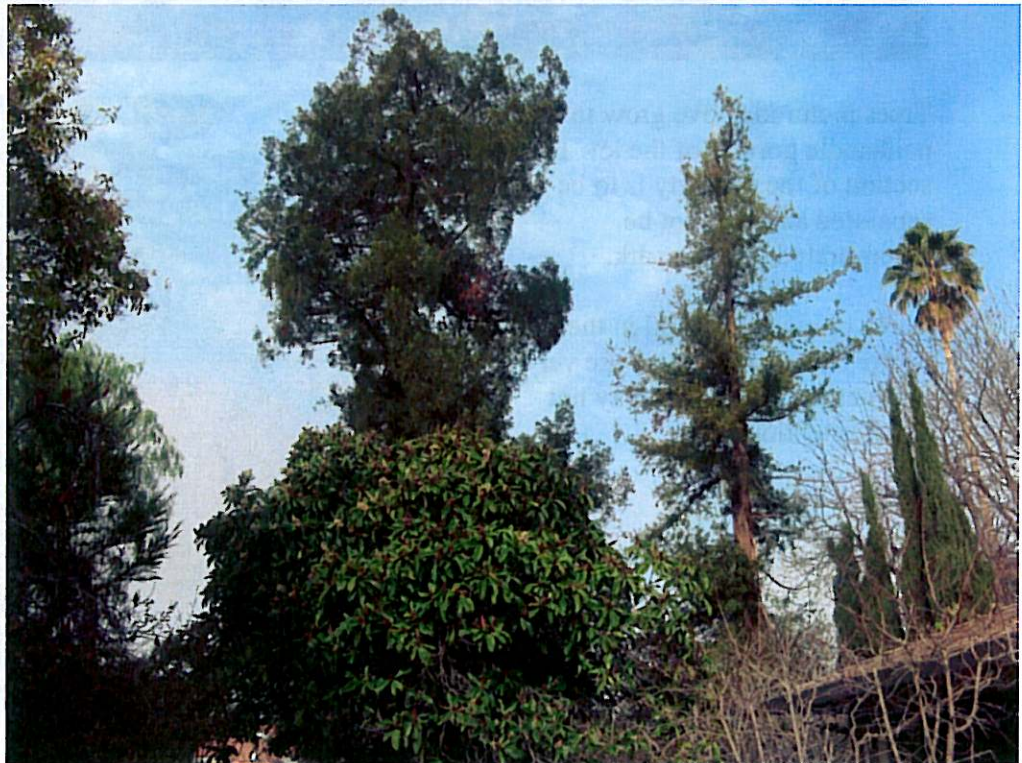
Trees 11 and 15 are heritage coast redwoods growing on the adjacent property to the north. They are quite majestic and should frame the project well.

Three heritage trees grow from adjacent properties and may be impacted by proposed construction or impact the safe use of the park. Trees #11 and 15 are significant coast redwood trees that stand near the western boundary fence on the adjacent residential parcel. They are spectacular trees that will provide aesthetic and biotic resources to the proposed park. Dead and broken branches should be removed from these two trees to avoid them falling and injuring people.
